Manhole Inspection Summary

Manhole # S13C__013MH

Insp Date: **1/24/09 12:56 PM**

Location Address: **510 FRANKLIN ST**

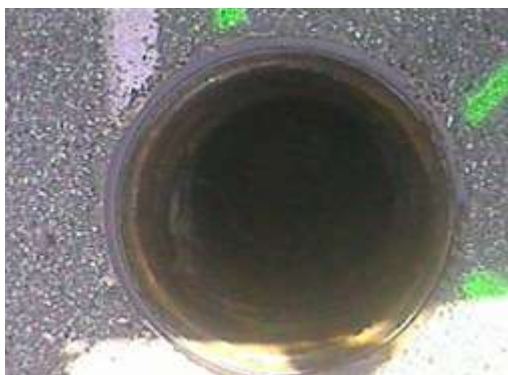
EVIDENCE OF SHEETING FROM CROWN OF ROADWAY

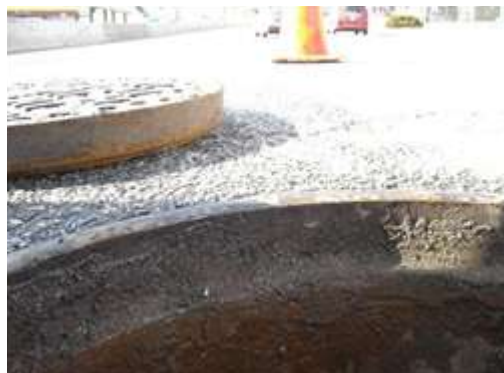
SHEETING

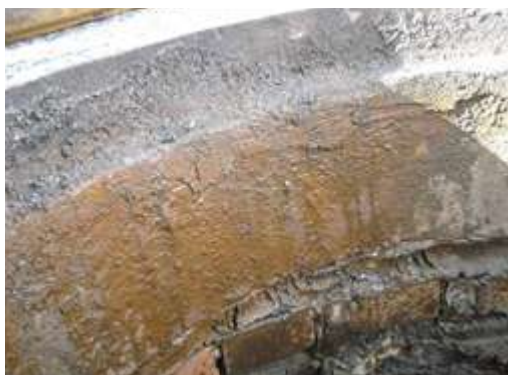
Defect 7

EVIDENCE OF INFLOW DUE TO SHEETING FROM CROWN OF ROADWAY

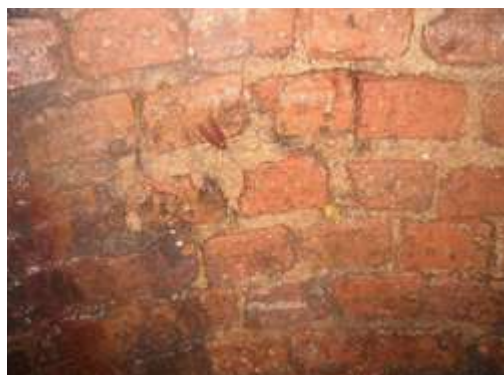
Defect 6

Condition: ☐ Sound ☒ **Cracked** ☐ Root Intrusion ☐ Loose Brick ☐ Deteriorated

Infiltration: ☐ None ☐ Joint ☒ **Cracks** ☒ **Mortar** ☐ Roots ☒ **Wall**

DETERIORATED AND CRACKED CORBEL WALL WITH MISSING MORTAR

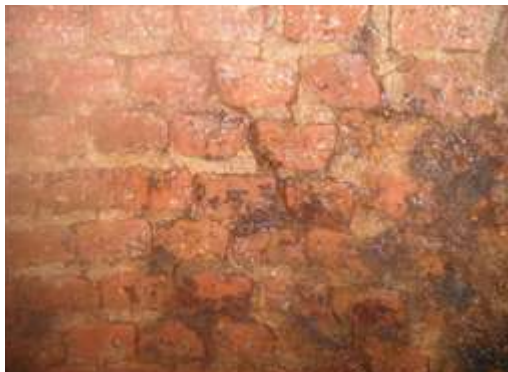
Defect 5

Condition: ☐ Sound ☒ **Cracked** ☐ Root Intrusion ☐ Loose Brick ☐ Deteriorated

Infiltration: ☐ None ☐ Joint ☒ **Cracks** ☒ **Mortar** ☐ Roots ☒ **Wall**

DETERIORATED BARREL WALL HAS LONG DIAGONAL CRACK, AND MISSING MORTAR IN MANY SPOTS

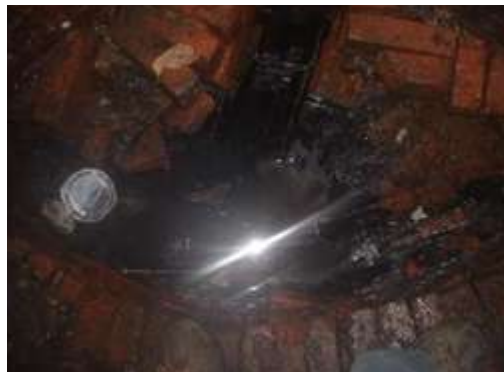
Defect 4

Condition: ☐ Sound ☐ Cracked ☐ Root Intrusion ☒ **Deteriorated** ☐ Leaks ☒ **Debris**

DEBRIS IN CHANNEL

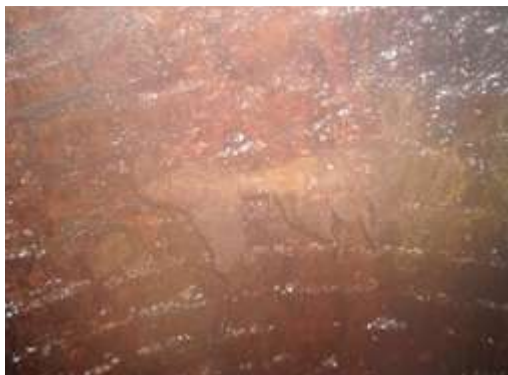
Defect 3

☒ **Evidence Of Surcharge** Depth: **5** (ft.) ☐ Active Surcharge Present

EVIDENCE OF SURCHARGE AT 5' STEP

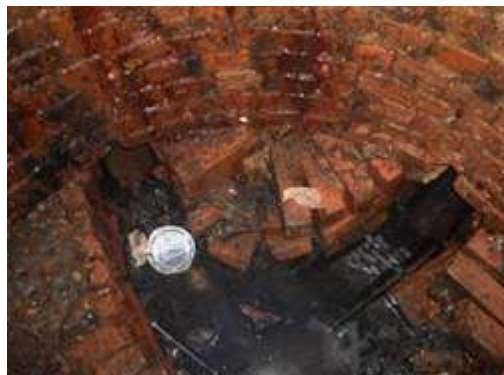
Defect 2

Condition: ☐ Sound ☒ **Cracked** ☐ Root Intrusion ☒ **Deteriorated** ☐ Leaks ☒ **Debris**

COLLAPSED BENCH

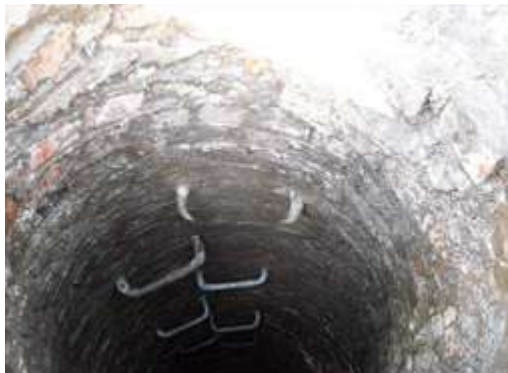
Defect 1

Count: **12** Missing: **1** ☒ **Corroded**

CORRODED AND MISSING TOP STEP

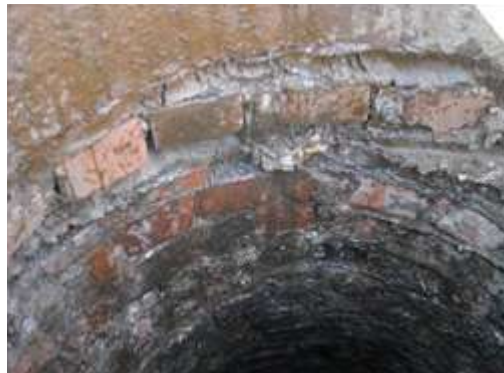
Condition: ☐ Sound ☒ **Cracked** ☐ Root Intrusion ☒ **Loose Brick** ☐ Deteriorated

CRACKED AND DETERIORATED CHIMNEY WITH LOOSE BRICKS

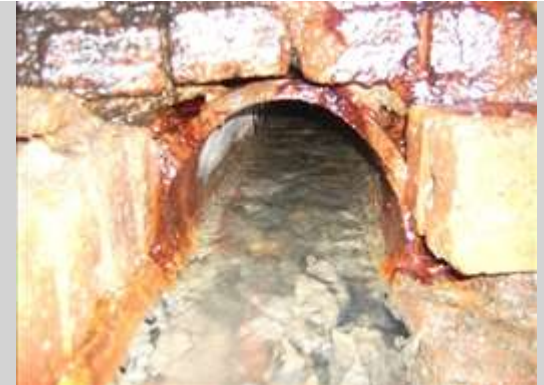
12 O'Clock Outflow

Pipe Height: **10.8** (in.) Rod and Bar (Angled)
Pipe Material: **Clay** ☐ Pipe Lined
Invert Depth: **22.18** (ft.) Flow Characteristics: **Slow**
Deposits: ☐ None ☐ Mud ☐ Gravy ☒ **Debris** ☐ Grease
Silt Depth: **2** (in.) Deposits Extent: **Medium**
Infiltration: **Evidence** Pipe Seal Cond: **Cracked**

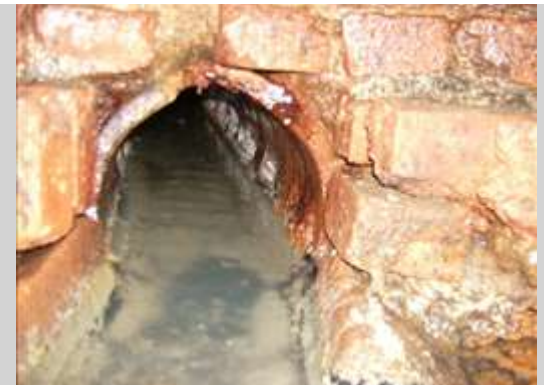
2 O'Clock Inflow

Pipe Height: **9.6** (in.) Rod and Bar (Angled)
Pipe Material: **Clay** ☐ Pipe Lined
Invert Depth: **22.15** (ft.) Flow Characteristics: **Slow**
Deposits: ☒ None ☐ Mud ☐ Gravy ☐ **Debris** ☐ Grease
Silt Depth: (in.) Deposits Extent:
Infiltration: **None** Pipe Seal Cond: **Cracked**

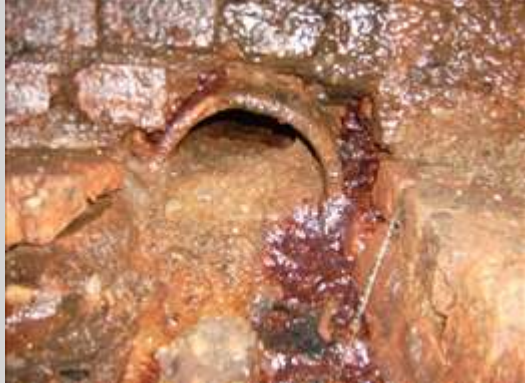
5 O'Clock Inflow

Deposits: ☐ None ☐ Mud ☒ **Sludge** ☒ **Debris** ☐ Grease

Silt Depth: **5** (in.) Deposits Extent: **Heavy**

Infiltration: **Evidence** Pipe Seal Cond: **Cracked**

Connects To: **Stub connection / abandoned**
